**Flood Control Project Maintenance**  
**2012 Structure Summary Report**  
**Overall Unit and Item Ratings**

**North Fork Feather River Diversion Channel Drop Structure No. 1 Through 7**

**North Fork Feather River Diversion Structure**

**Flood Control Project Maintenance****Unit Cover Sheet****2012 Structure Inspection Results****Plumas County**

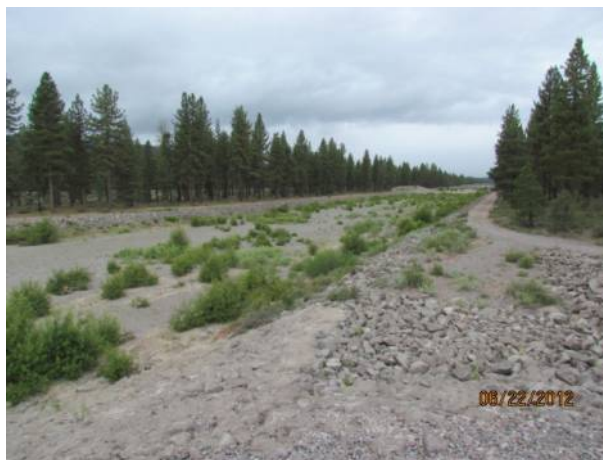
Levee Mile Report Line	1
Start Levee Mile	
End Levee Mile	
Location	
Category	Structures
Item	Photo Documentation

View of structure 7 looking towards 6 & 5.

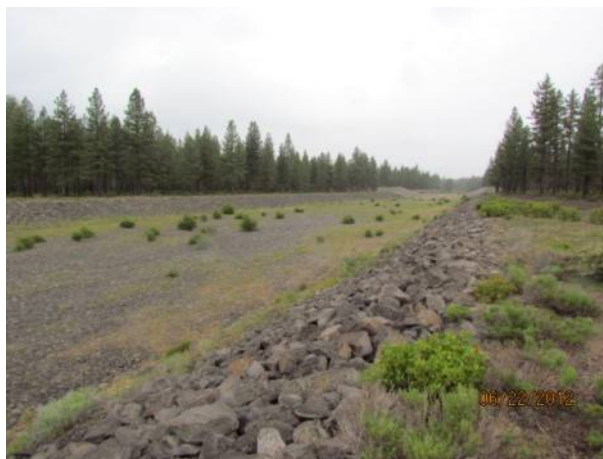
Levee Mile Report Line	15
Start Levee Mile	0.00
End Levee Mile	0.00
Location	
Category	Structures
Item	Concrete Surfaces

View of drop structure 1, looking towards the Feather River.

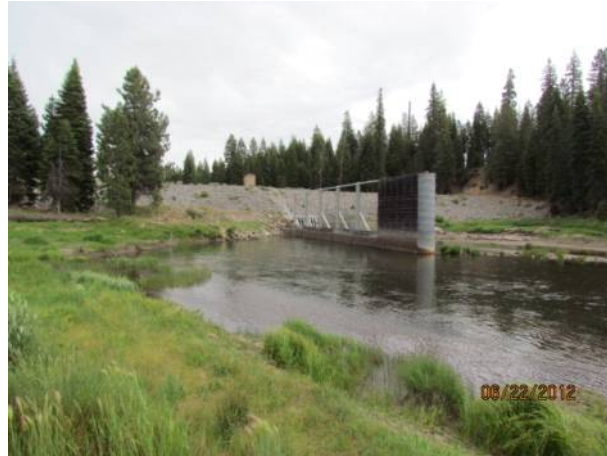
Levee Mile Report Line	1
Start Levee Mile	
End Levee Mile	
Location	
Category	Structures
Item	Photo Documentation

View of the dam & structure.

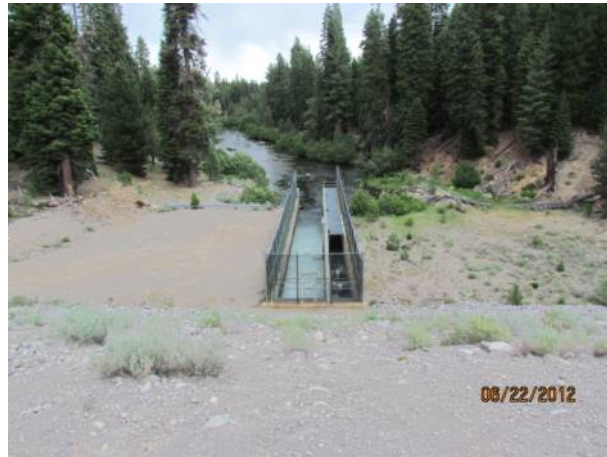
Levee Mile Report Line	2
Start Levee Mile	0.00
End Levee Mile	0.00
Location	
Category	Structures
Item	Vegetation & Obstructions

View of the outfall structure & slope of the dam.

LMR No.	Levee Mile		Category	Item	Location *	Rating **	Action/Comment	GPS Latitude/Longitude		Issue No.
	Start	End						Start	End	Photo
1			Structures	Photo Documentation		N		40.302640 ° 121.263190 °	40.302640 ° 121.263190 °	23 Y
2	0.00	0.00	Structures	Vegetation & Obstructions		A	Inspector Comments: Remove all vegetation from the face of the dam area before winter.	40.302810 ° 121.261940 °	40.302810 ° 121.261940 °	1 Y
3	0.00	0.00	Structures	Shoaling / Sedimentation		A		40.302640 ° 121.263190 °	40.302640 ° 121.263190 °	2
4	0.00	0.00	Structures	Erosion / Bank Caving		A		40.302640 ° 121.263190 °	40.302640 ° 121.263190 °	3
5	0.00	0.00	Structures	Revetments		A		40.302640 ° 121.263190 °	40.302640 ° 121.263190 °	4
6	0.00	0.00	Structures	Encroachments		A		40.302640 ° 121.263190 °	40.302640 ° 121.263190 °	5 Y
7	0.00	0.00	Structures	Culverts: Inlets / Outlets		A		40.302640 ° 121.263190 °	40.302640 ° 121.263190 °	6

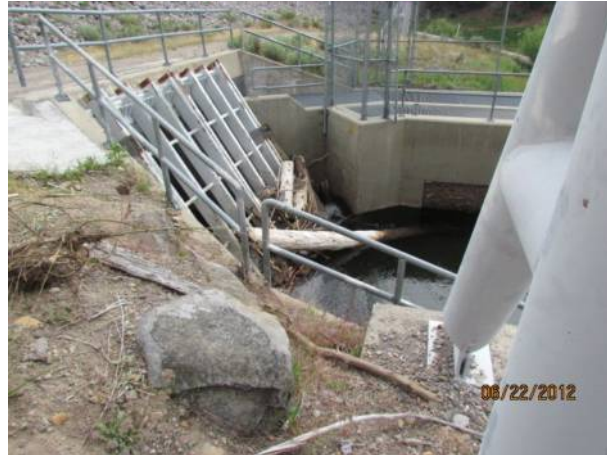
Levee Mile Report Line	10
Start Levee Mile	0.00
End Levee Mile	0.00
Location	
Category	Structures
Item	Trash Racks
View of the trash with debris blocking the flow of water.	
rduffey_t_20120710_010.jpg

8	0.00	0.00	Structures	Culverts: Breaks / Holes / Cracks		A		40.302640 ° 121.263190 °	40.302640 ° 121.263190 °	7
9	0.00	0.00	Structures	Metal Pipes		A		40.302640 ° 121.263190 °	40.302640 ° 121.263190 °	8
10	0.00	0.00	Structures	Trash Racks		A	Inspector Comments: Remove all debris from the trash rack.	40.302750 ° 121.262170 °	40.302750 ° 121.262170 °	9 Y
11	0.00	0.00	Structures	Flap Gates		N	Inspector Comments: This item does not apply to this inspection.	40.302640 ° 121.263190 °	40.302640 ° 121.263190 °	10
12	0.00	0.00	Structures	Sluice/Slide Gates		A		40.302640 ° 121.263190 °	40.302640 ° 121.263190 °	11
13	0.00	0.00	Structures	Electric Gate Operators		N	Inspector Comments: This item does not apply to this inspection.	40.302810 ° 121.261940 °	40.302810 ° 121.261940 °	12 Y
14	0.00	0.00	Structures	Manual Gate Operators		A		40.302640 ° 121.263190 °	40.302640 ° 121.263190 °	13
15	0.00	0.00	Structures	Concrete Surfaces		A		40.302640 ° 121.263190 °	40.302640 ° 121.263190 °	14

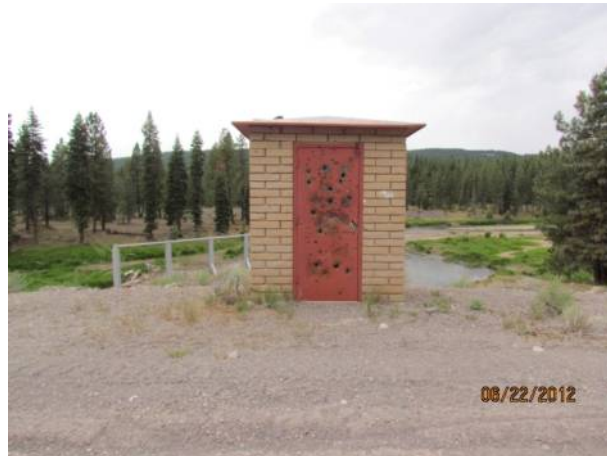
Levee Mile Report Line	13
Start Levee Mile	0.00
End Levee Mile	0.00
Location	
Category	Structures
Item	Electric Gate Operators
Gauging house on top of the dam, use discontinued due to vandalism.	
rduffey_t_20120710_011.jpg
